## Church of St Mary, Chilton Foliat

### Quinquennial Inspection

**August 2023**

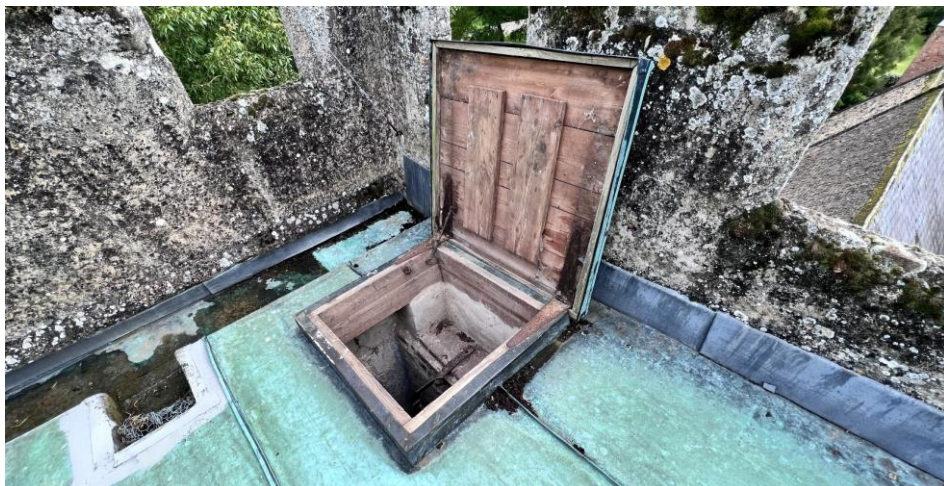
- 4.2.1\* The tower roof accessed by a metal fixed ladder (in two parts) from the bell chamber. The ladder is a little awkward, and the roof hatch could do with a handle on the inside to pull it shut (figure 2).

Figure 2 – Tower roof hatch – install an internal handle.

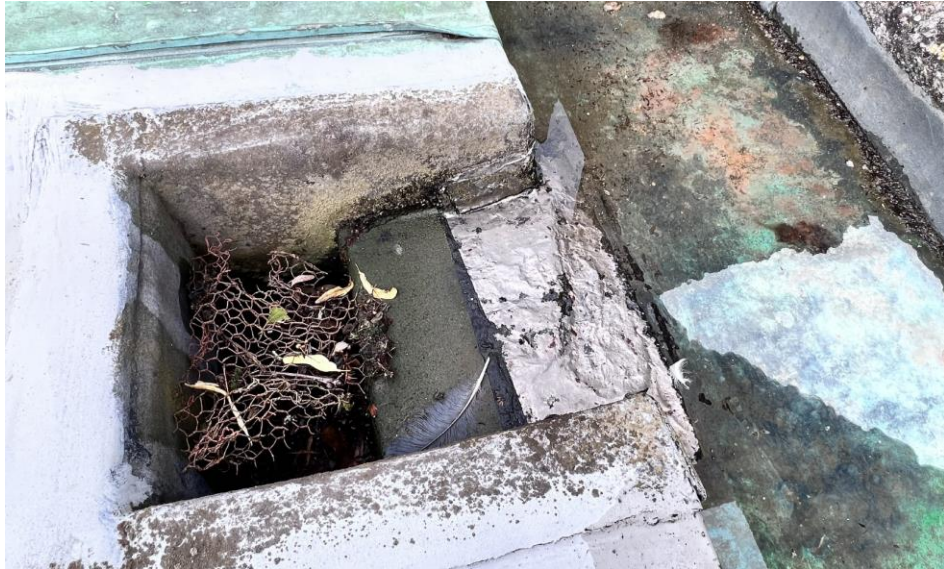
- 4.2.2\* There is evidence of leaking at outlets to internal downpipes, causing decay to the timber hopper linings. There are previous flashband repairs to every outlet that are now failing (figure 3). The gutters and hoppers now need renewing, ideally in lead.

Figure 3 – Tower roof – renew gutters and hoppers in lead.

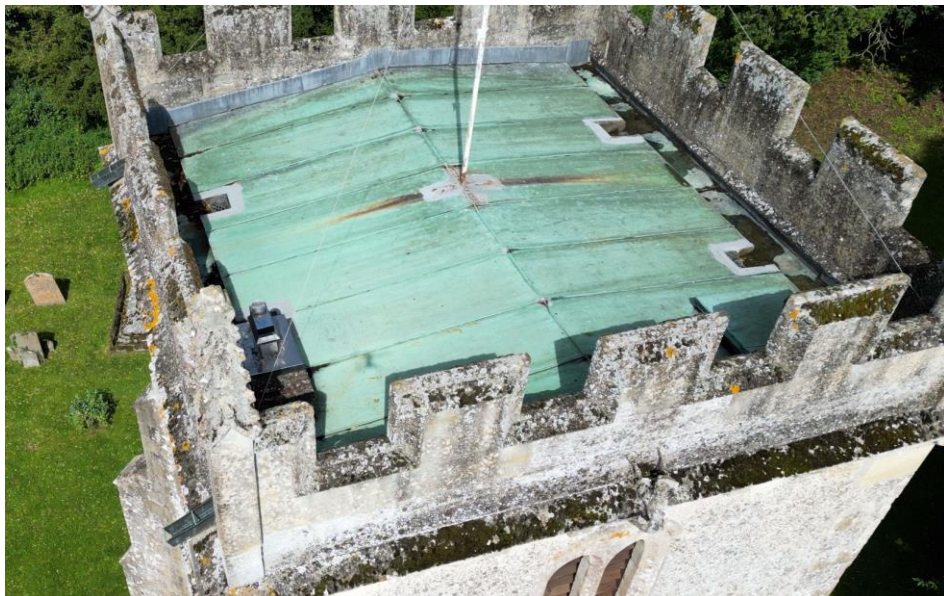
- 4.2.3\* The copper roof appears to be sound, though due the failure of the copper elsewhere, and the necessity to disturb the roof when repairing the gutters and hoppers, it might be sensible to renew the whole roof in lead (figure 4).

Figure 4 – Tower roof – consider renewing in lead.

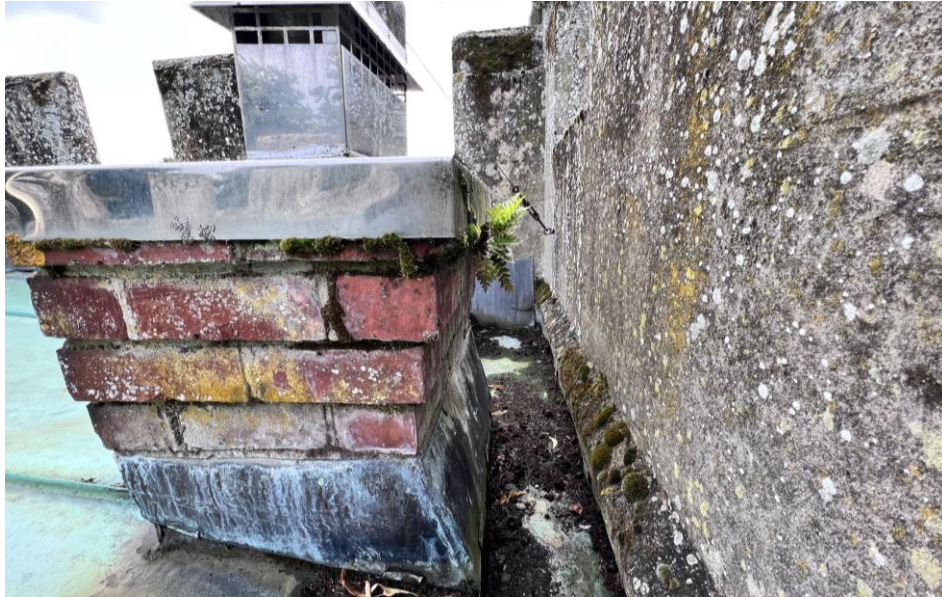
- 4.2.4\* The chimney has some vegetation growing from it that should be removed (figure 5).

Figure 5 – Tower roof, chimney – remove plant growth.

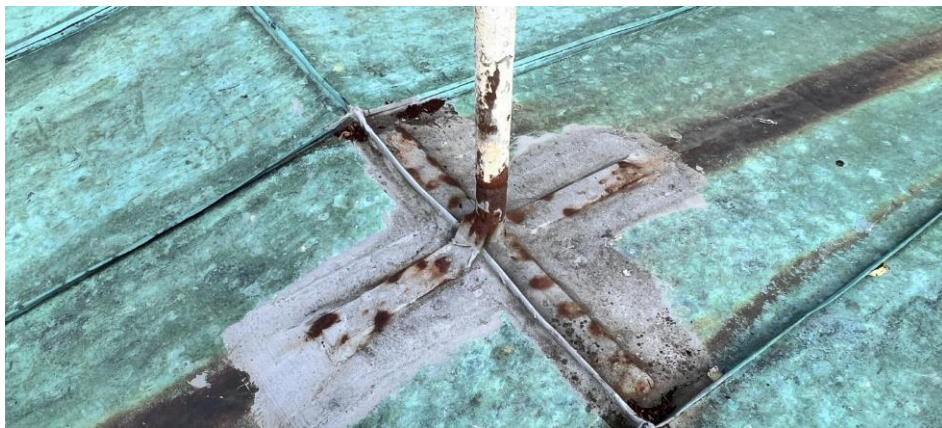
- 4.2.5\* The flagpole is a little rusty at the bottom and may require some redecoration at some point (figure 6).

Figure 6 – Tower roof – redecorate flagpole.

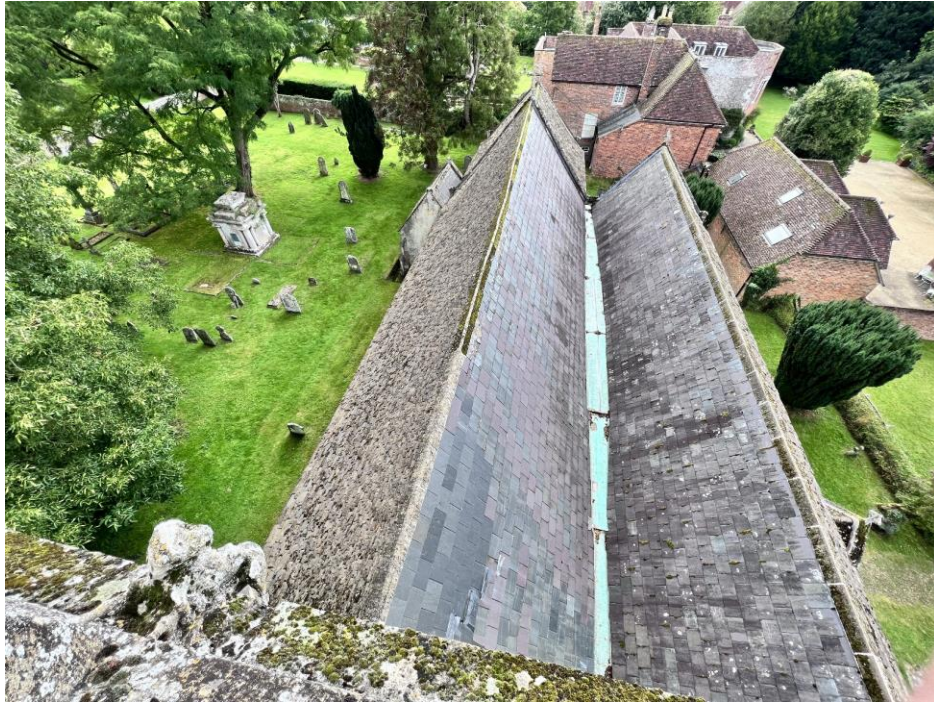
- 4.3.1\* The outside faces of both these roofs are stone tiles while the inside faces are slate (figure 7). There are several broken and slipped slates to inner face of both roofs that should be reinstated.

Figure 7 – Nave and south aisle roof – reinstate slipped slates.

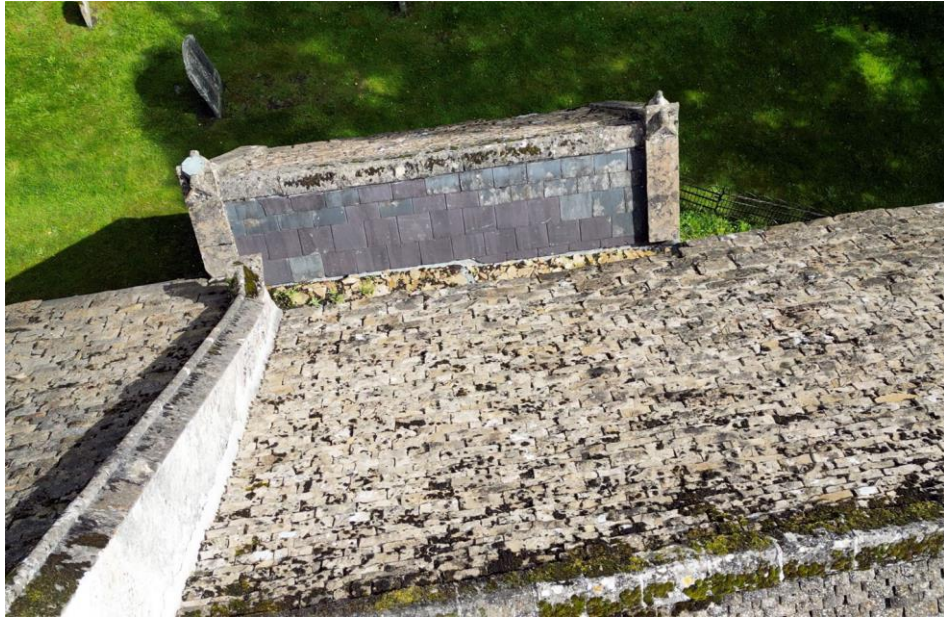
Figure 8 – Vestry roof, viewed from the tower.

- 4.5.1\* The outer slope of the vestry roof is stone tiles while the inner slope is slate (figure 8). There are a couple of broken slates and some of the stone ridge tiles have fractured and may need some repair at some point.

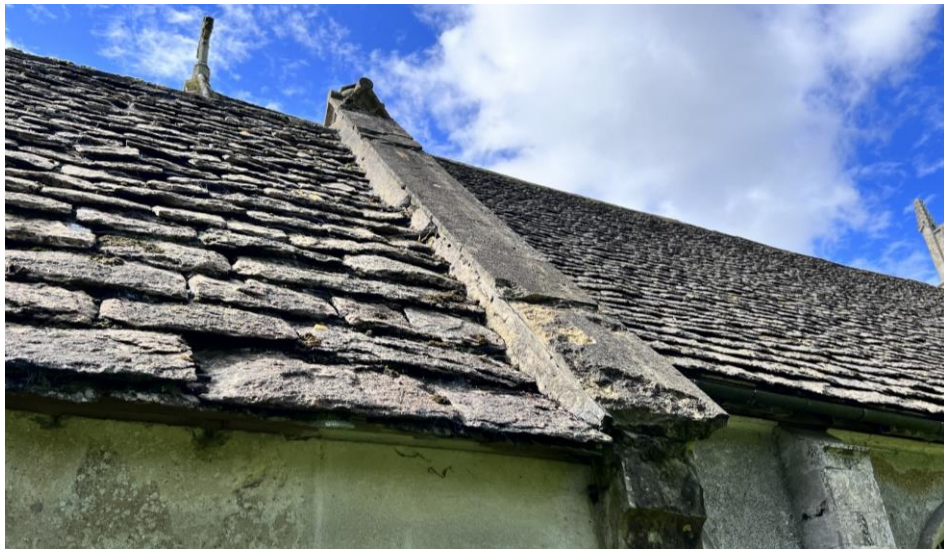
- 4.5.2\* There is some stone damage to the west end coping that may need some repair – maybe at the same time as the ridge tiles (figure 9).

Figure 9 – Vestry roof – repair/replace damaged copings.

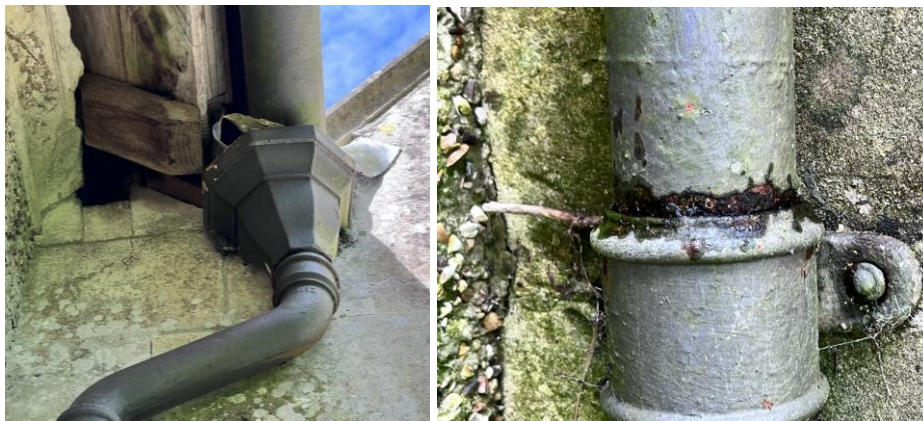
5.2.2\* The downpipe and hopper in the corner of the chancel and vestry is blocked (see also 4.4), with signs of overflowing water down the corner – the wall is quite green behind the downpipe, and one of the downpipe joints is beginning to rust (figure 10). It requires clearing.

Figure 10 – Chancel/vestry downpipe – clear.

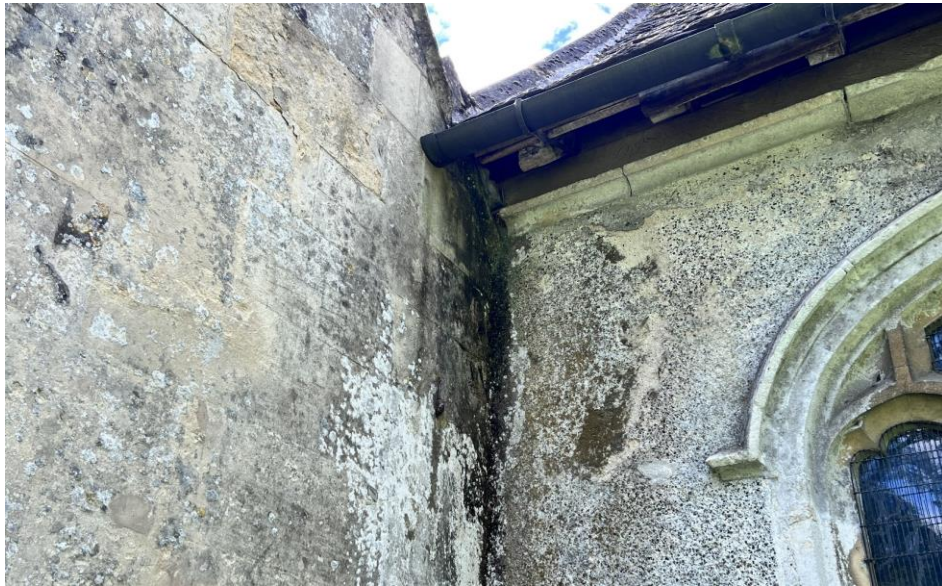
- 5.2.3\* The north east corner nave gutter, where it meets the vestry, is overflowing and may need clearing (figure 11). The window head is a little green, suggesting water may be overshooting this stretch of gutter. This should be investigated.

Figure 11 – Nave, north – investigate overflowing gutter.

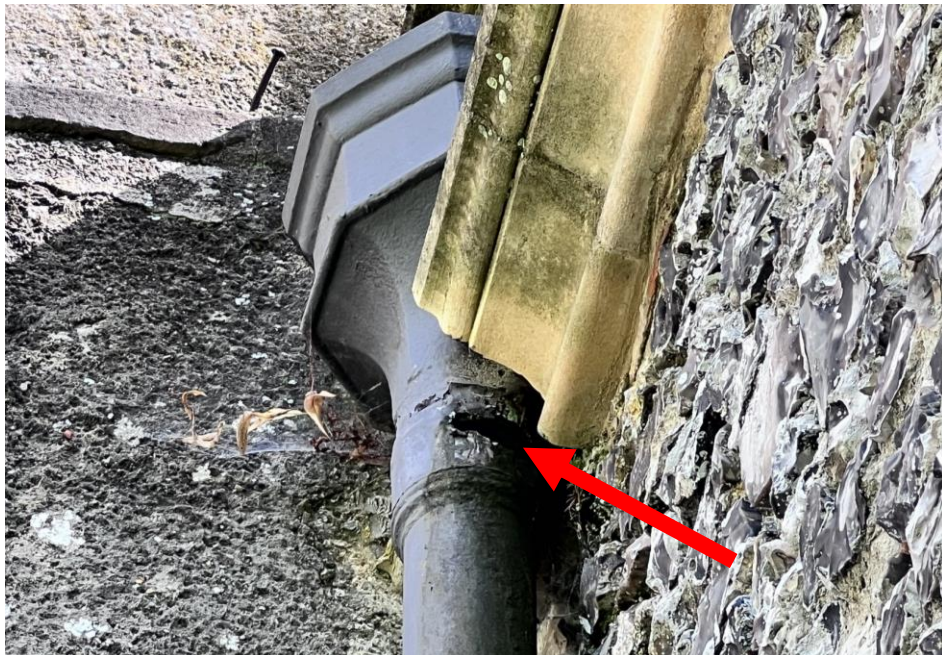
- 5.2.4\* As mentioned in the previous inspection, the tower west end valley gutter hopper has a hole in it (figure 12). This requires repair.

Figure 12 – Tower – repair hole in hopper.

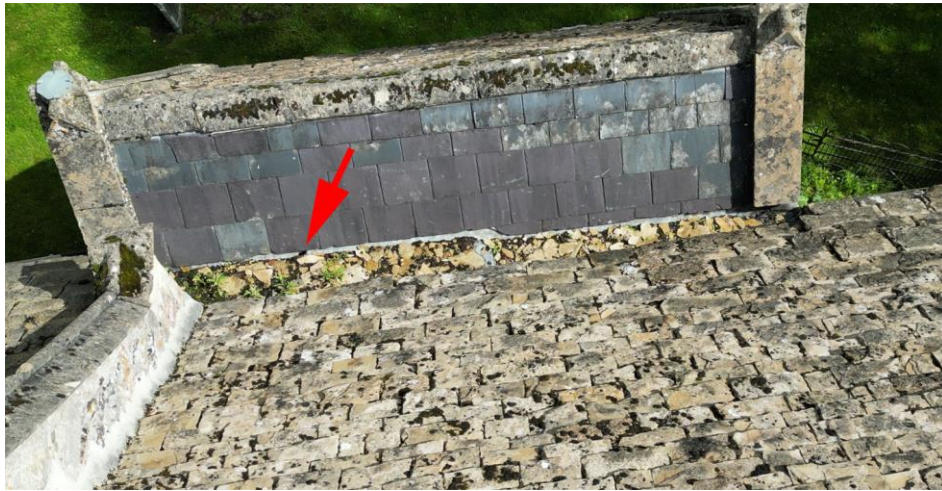
The chancel roof is covered with stone slates on both sides. There has been quite a bit of delamination of the stone tiles on the north side (probably frost damage). These fragments of stone have filled the vestry valley gutter and need to be cleared away, especially as they have probably blocked the east end hopper causing it to overflow.

- 5.2.5\* The lead valley gutter between the vestry and the chancel is full of fragments, and there appears to be a hole in the lead (figure 13). The gutter requires clearing and inspecting.

Figure 13 – Vestry/chancel valley gutter – clear and inspect.

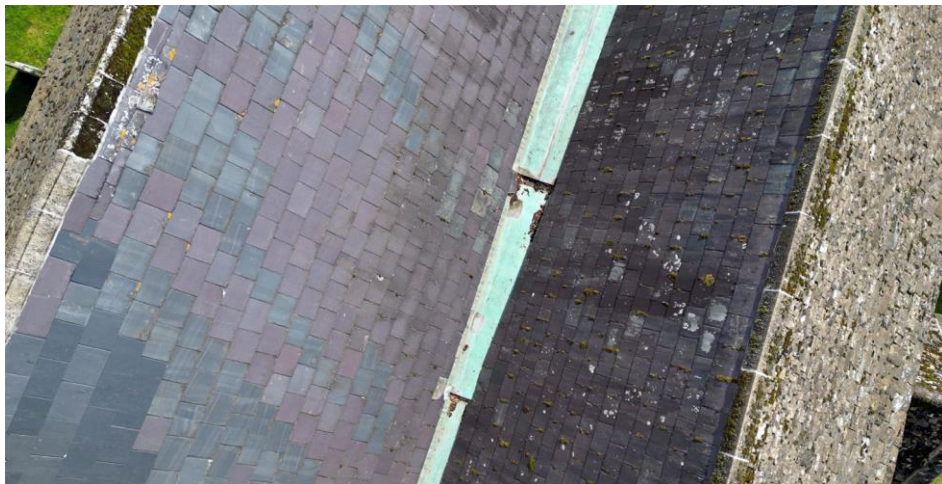
- 5.2.6\* The copper valley gutter between the south aisle and the nave has previous repairs (figure 14). There are currently no signs of any water ingress, though it is probably reaching the end of its life and, at some point, will split and fail. It would be worth planning to renew this gutter in the near future.

Figure 14 – Nave/south aisle valley gutter – renew.

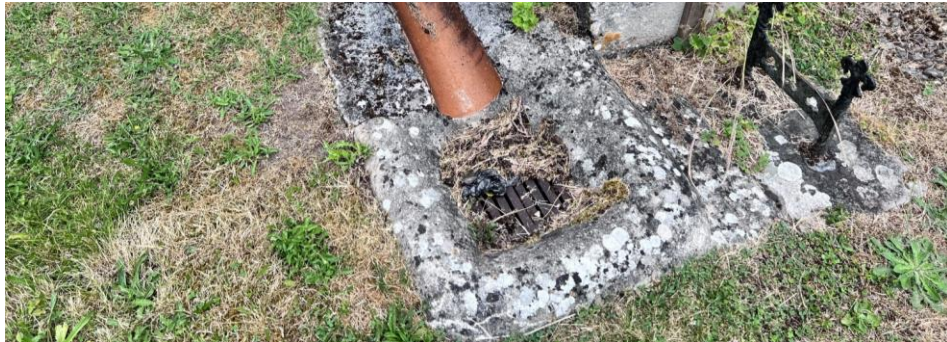
- 5.3.1\* The gullies by porch have a build-up of debris that requires clearing (figure 15). The north gully of the nave also requires clearing. Ideally all the gullies should be rodded through to ensure there is no blockage.

Figure 15 – Porch – clear gullies.

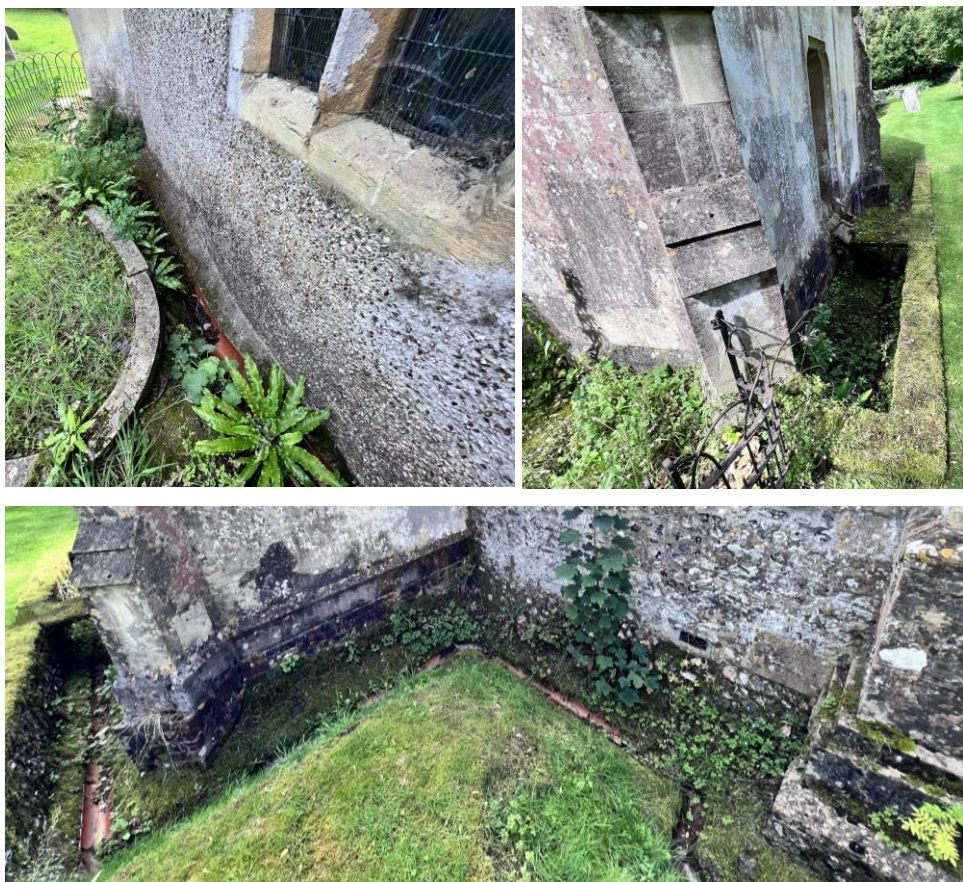
- 5.3.2\* The perimeter drainage channel has quite a bit of plant growth that requires clearing (figure 16).

Figure 16 – Perimeter drainage channel – clear plant growth.

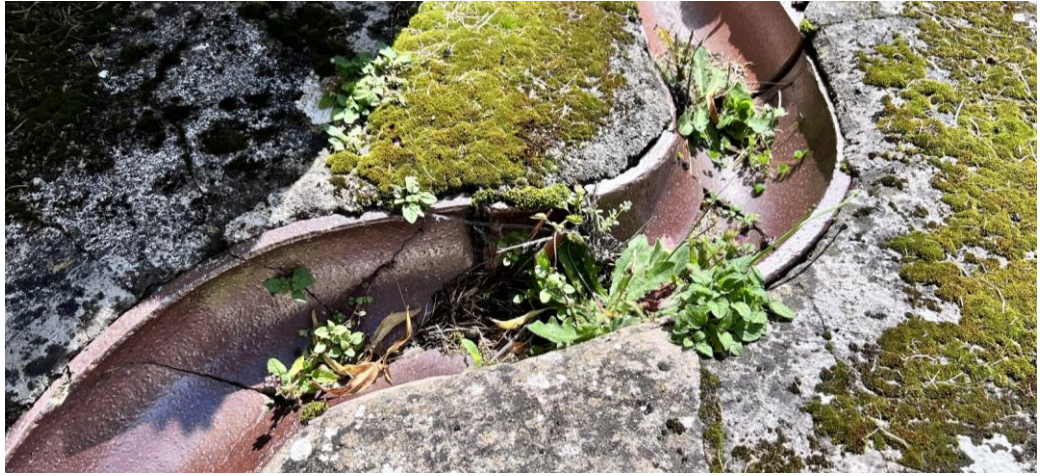
- 5.3.3\* Many of the curved section of perimeter drainage channel are broken, especially on the south side (figure 17). These could do with some repair.

Figure 17 – Perimeter drainage channel- repair broken sections.

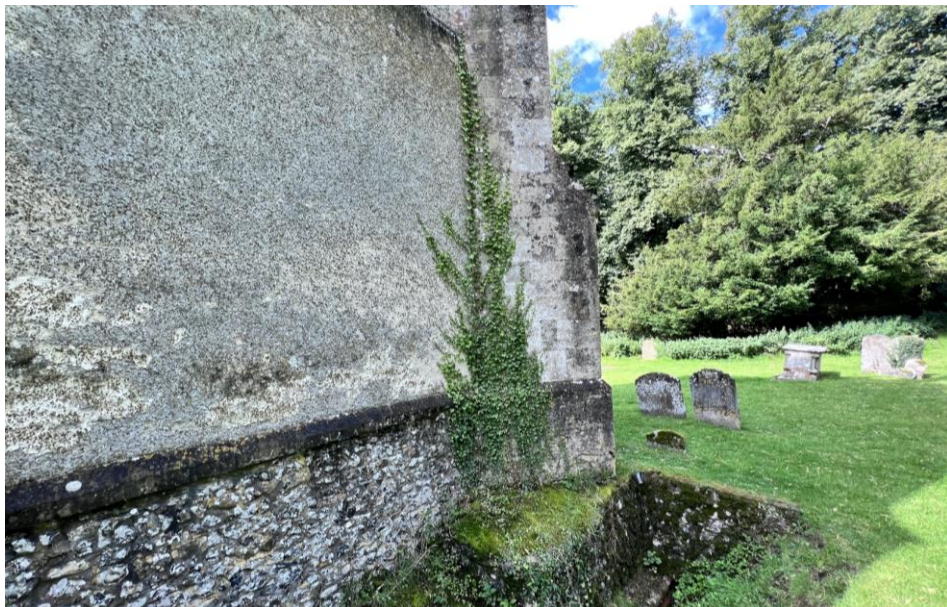
6.2.2\* There is ivy growing up the north west corner buttress of the tower (figure 18). This should be removed and any resulting holes repointed with lime mortar.

Figure 18 – Tower, north west buttress – remove ivy.

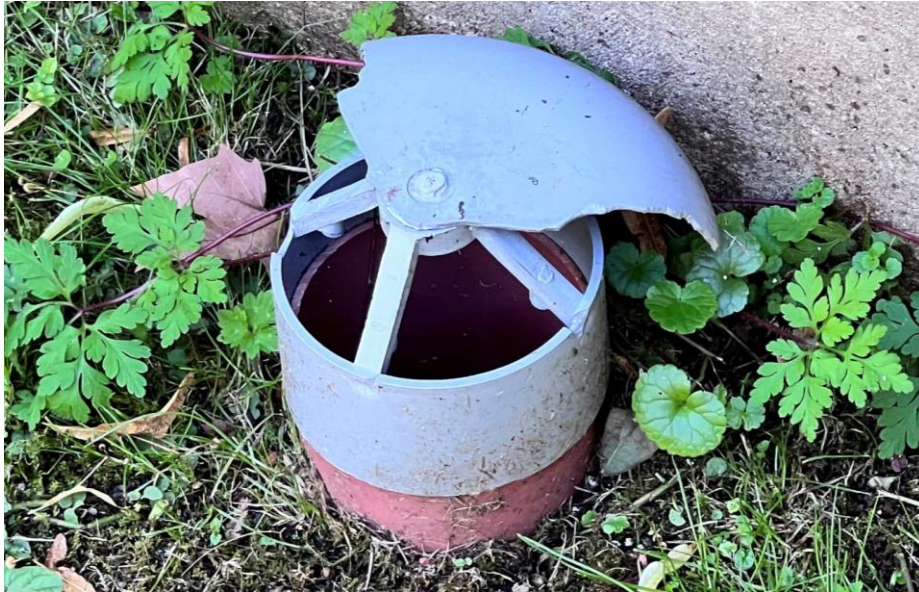
6.2.5\* The toilet vent cap in the ground at the west of the tower has broken and requires replacing (figure 19).

Figure 19 – Tower, west – replace vent cap.

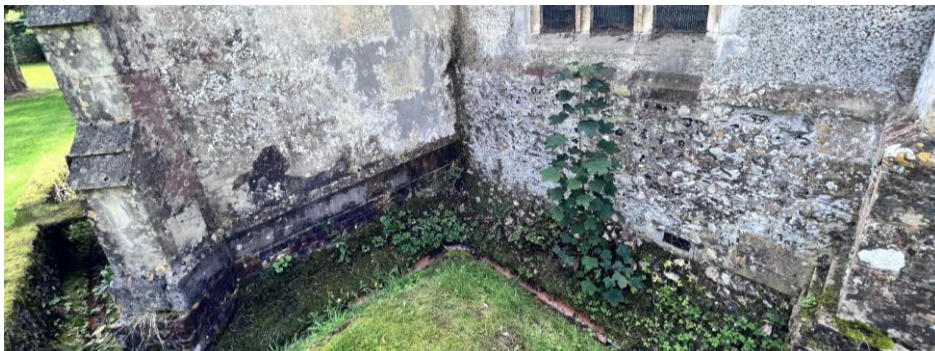
6.3.1\* The north side of the nave is generally in good condition. There is some moss growth on some of the buttresses that could do with clearing before it causes damage to the stone. There is also a sapling growing up next to the wall, below the area of overflowing gutter, just west of the vestry (figure 20). The sapling needs to be removed, along with other low-level vegetation.

Figure 20 – Nave, north elevation – remove sapling.

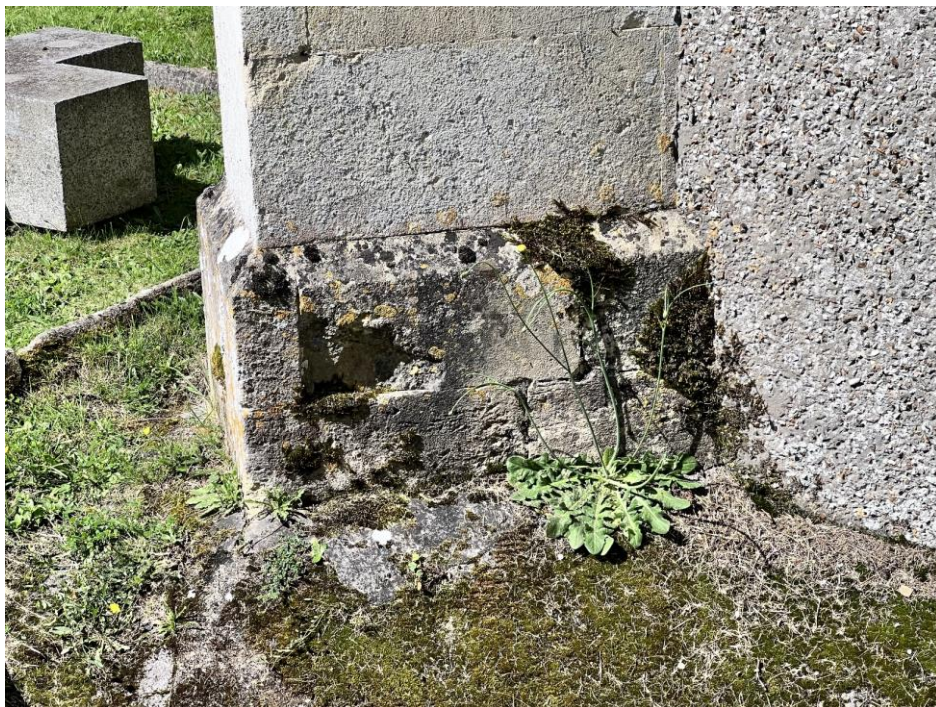
6.4.1\* The east end of the chancel is generally in good condition. There is a little staining to the render below the window, caused by water run-off. There is a little damage the buttress plinths on both sides (figure 21). All vegetation should be removed and the damage repaired with lime mortar.

Figure 21 – Chancel, buttress plinths – clear vegetation, repair.

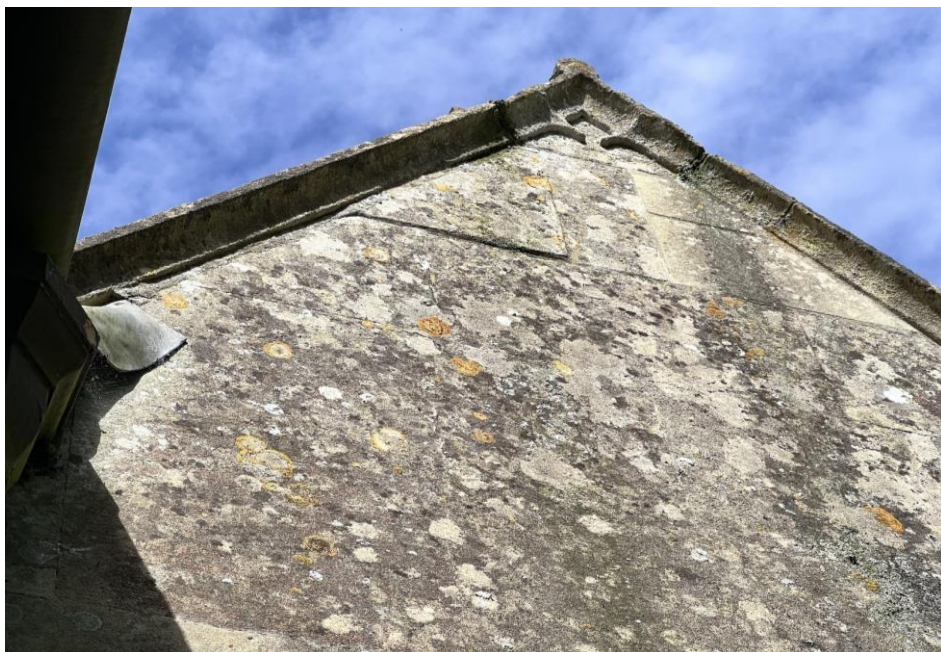
- 6.5.1 The north elevation of the vestry is a little stained and discoloured but appears solid with no major work required.
- 6.5.2\* The east and west ends of the vestry have suffered some weathering and discolouration but are generally in good condition. There is a high-level stone unit at the east end that appears to sit slightly proud of the face (figure 22). It should be reassessed at the next inspection.

Figure 22 – Vestry, east end – reassess at next inspection.

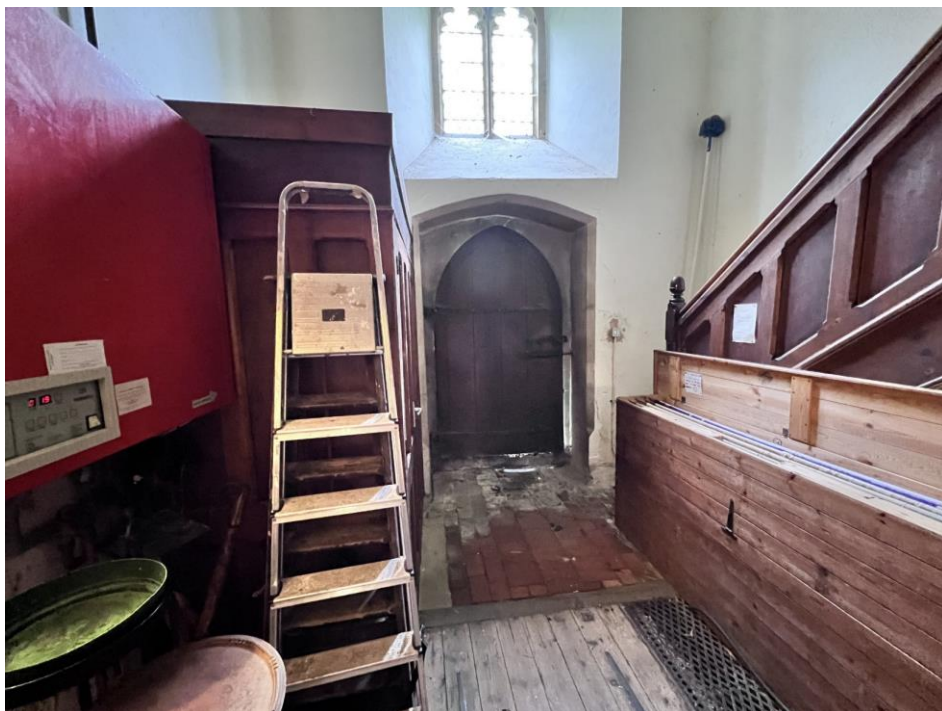
7.2.1\* The lower tower has some areas of decorative and plaster damage that should be picked up in the next redecoration (figure 23). There are patches of flaking paint on the ceilings that will require rubbing down and repainting. All redecoration work should be carried out using a breathable paint such as Earthbourne clay paint.

Figure 23 – Lower tower – redecorate at some point.

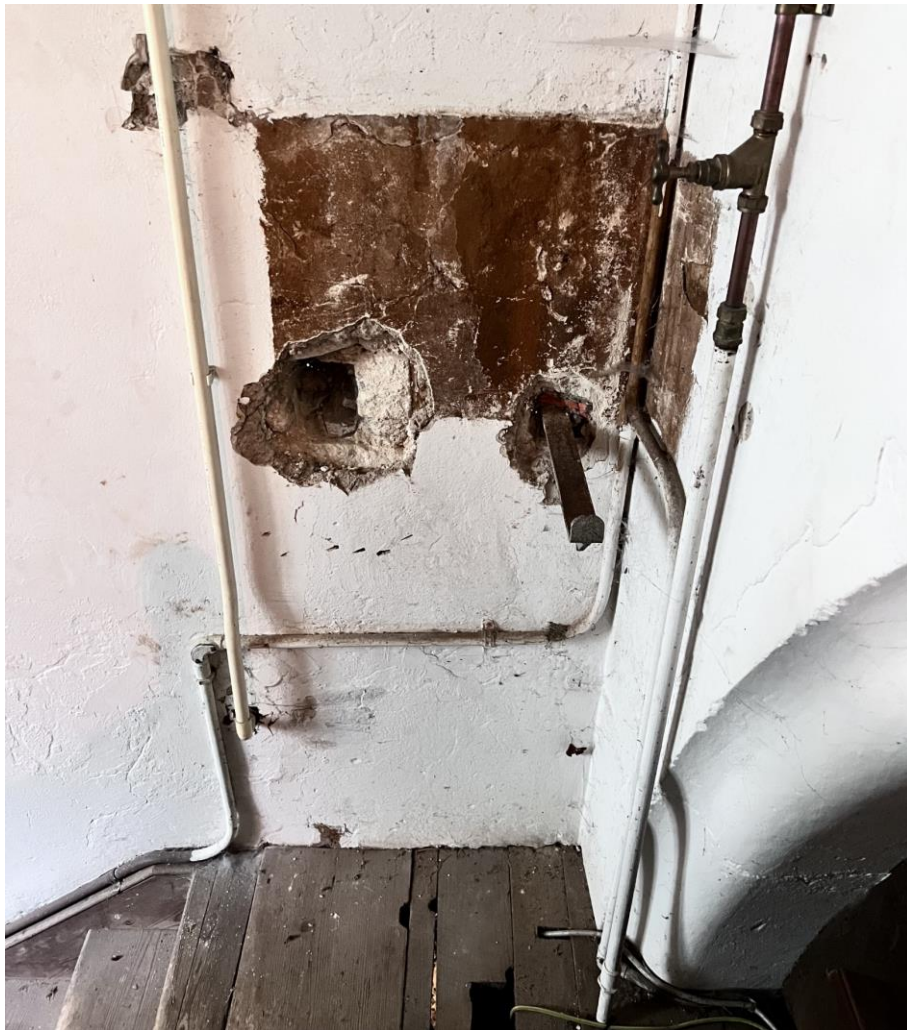
7.2.2\* There is a wooden staircase to a landing area, from which there is a metal fixed ladder to the bell ringing chamber. The stair landing has a hole in the floor, and damage to the wall where a previous header tank has been removed (figure 24). It would be good to repair and redecorate this area. The hatch to the ringing chamber has a split in the wood.

Figure 24 – Lower tower landing – repair wall and floor, redecorate.

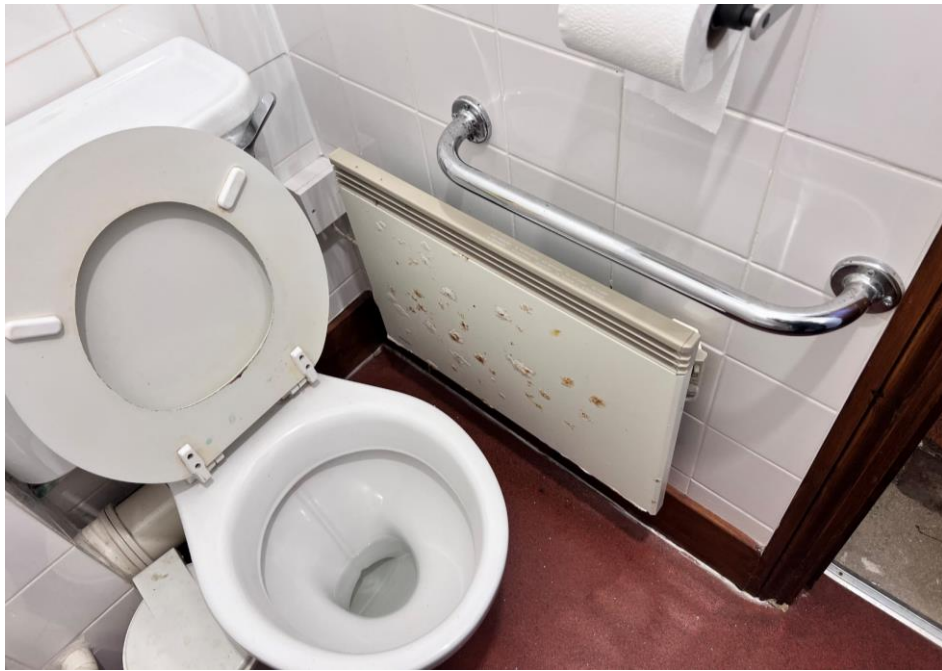
- 7.2.3\* The toilet is generally in good clean condition, though the toilet seat was a little wobbly at the time of the inspection and could do with some adjusting or replacing. There are rust patches on the surface of the electric panel heater, most likely caused by condensation (figure 25). The condensation levels can be reduced by using the heating to ensure that the room does not drop below dewpoint. It may also be beneficial to keep the room more ventilated, either by installing vents or leaving the door open when not in use.

Figure 25 – Toilet – reduce condensation levels.

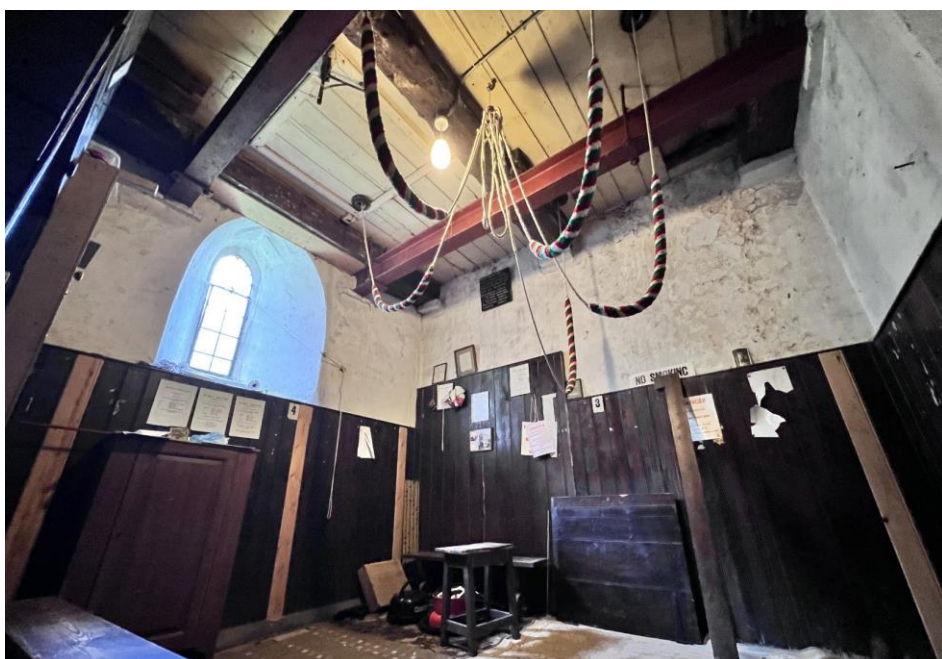
- 7.3.1\* The bell ringing chamber is accessed by a fixed metal ladder and rising hatch from the lower tower. The wall above the hatch has some plaster damage, and there is some flaking plaster that should be repaired and redecorated at some point (figure 26). There are also quite a few cobwebs that could do with clearing.

Figure 26 – Bell ringing chamber – clean cobwebs, repair plaster, redecorate.

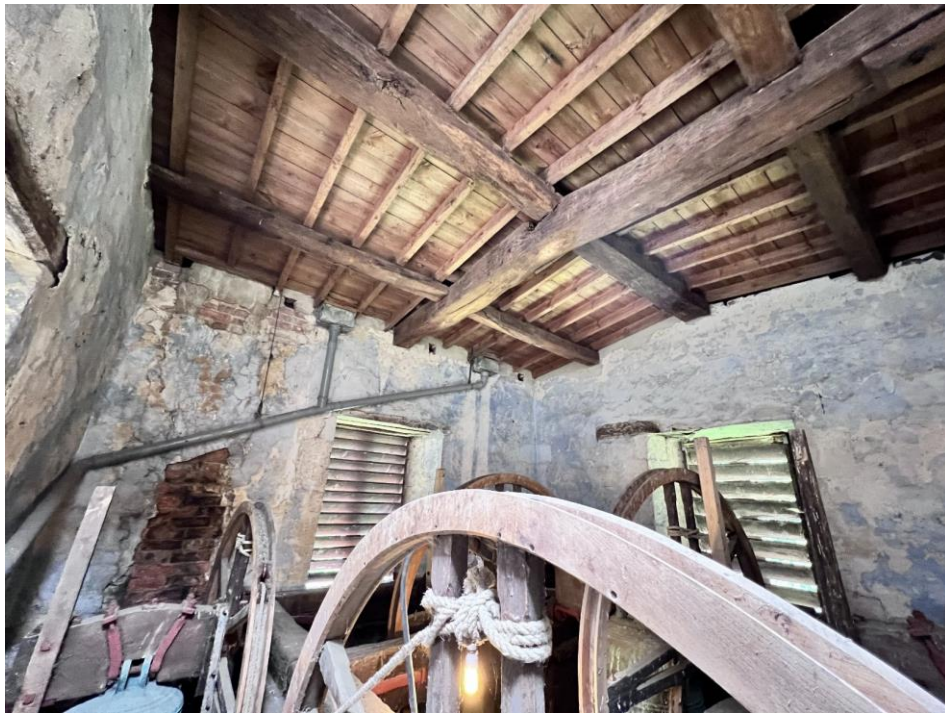
- 7.4.1 The bell chamber is accessed by way of a wooden ladder (not fixed) and sliding hatch from the bell ringing chamber. It houses five bells that are not regularly rung, only for occasions such as weddings etc. At the time of the inspection, the church was arranging a bell inspection to ensure they remain in good working order.
- 7.4.2\* There is quite a bit of plaster damage in the bell chamber (figure 28). This is mostly resulting from the failed tower roof gutter outlets that have allowed water in over the years. At some point it would be good to remove the loose and blown plaster and renew it with new lime plaster, and paint with a breathable paint.

Figure 28 – Bell chamber – carry out plaster repairs.

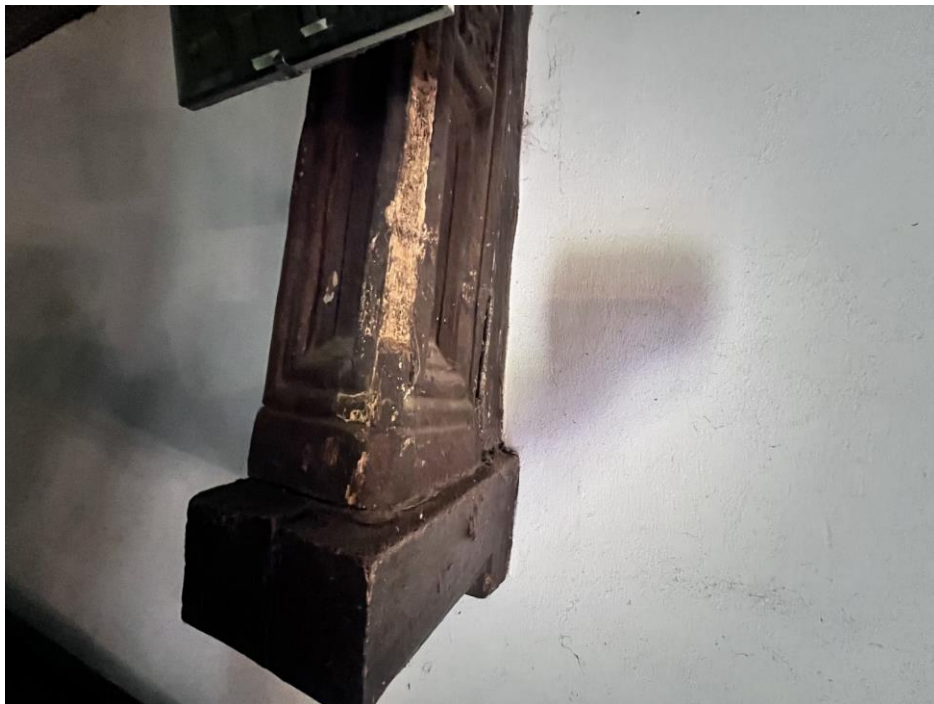
- 7.5.2\* The nave pew platforms have signs of beetle attack and some historic woodworm holes. The middle south section is bouncy around the fourth pew from the front, and the joists are most likely rotten. This section should be lifted, any rotten joists repaired or replaced, and the boarding re-laid.
- 7.5.3\* The north east window of the nave has some stonework delamination in top of stone arch. This should be casually monitored and reassessed at the next inspection.
- 7.5.4\* The internal roof structure of the nave appears to be in sound condition with no signs of water ingress. There is some beetle attack to one of the wall posts that should be treated if active (figure 30). There is some historic staining in places. It would be good to re-stain the boards at some point. There are a few runs down the wall below the ceiling at the west end, most likely caused by condensation.

Figure 30 – Nave roof wall post – treat beetle attack.

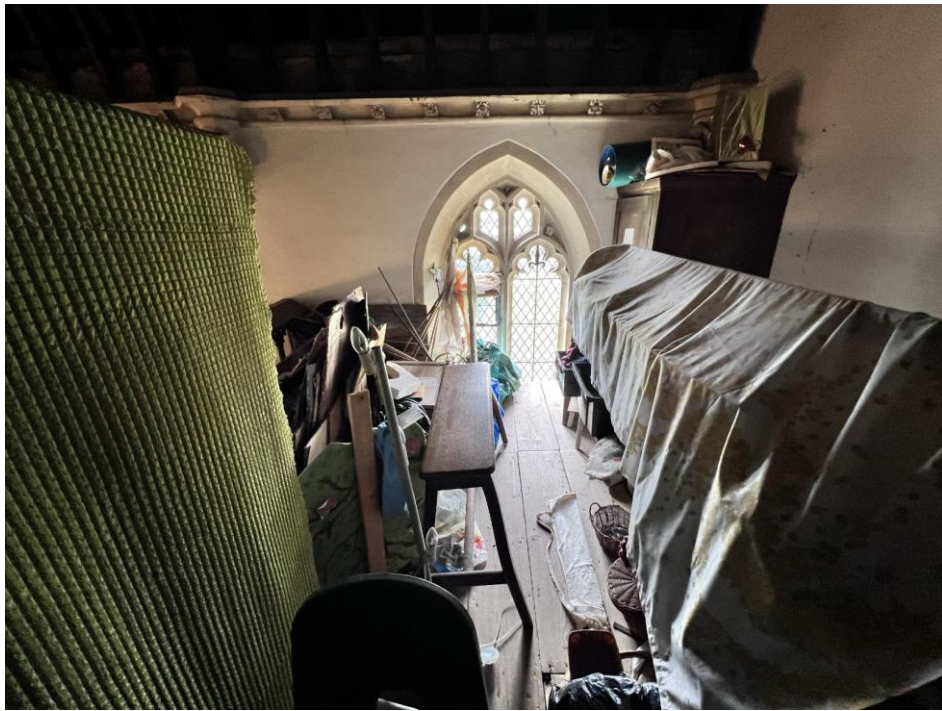
- 7.5.5\* The organ gallery, that spans the west end of the nave and south aisle, is accessed by a wooden staircase that is in good condition. As well, as housing the organ, the gallery is used as storage and is a little cluttered (figure 31). There are a few loose floorboards that should be casually monitored and reassessed at the next inspection.

Figure 31 – Organ gallery – used as a storage area.

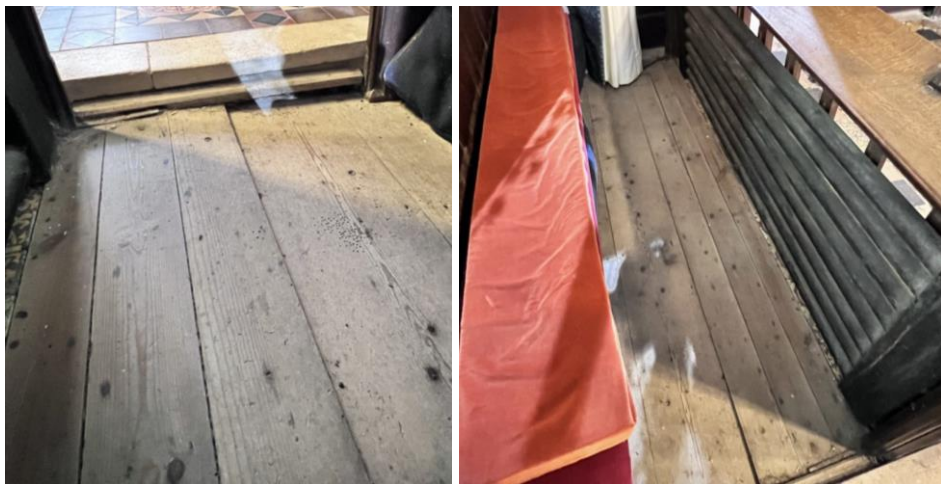
- 7.7.2\* There is some bounce in the floor below the choir pews, and there are signs of insect attack (figure 34). The boards require lifting, any rotten joists repaired or replaced, and the boards re-set.

Figure 34 – Chancel, choir pew platforms – repair/replace rotten joists.

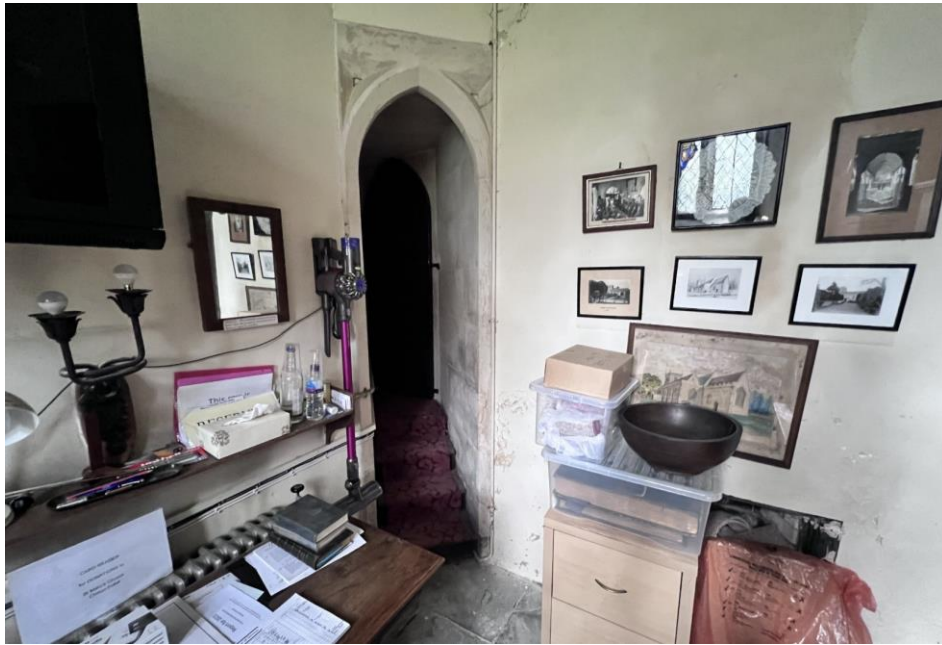
- 7.8.1\* The vestry is accessed from the chancel. There were a few cobwebs at the time of the inspection and it would be good to give the area a light clean (figure 35).

Figure 35 – Vestry – clear cobwebs.

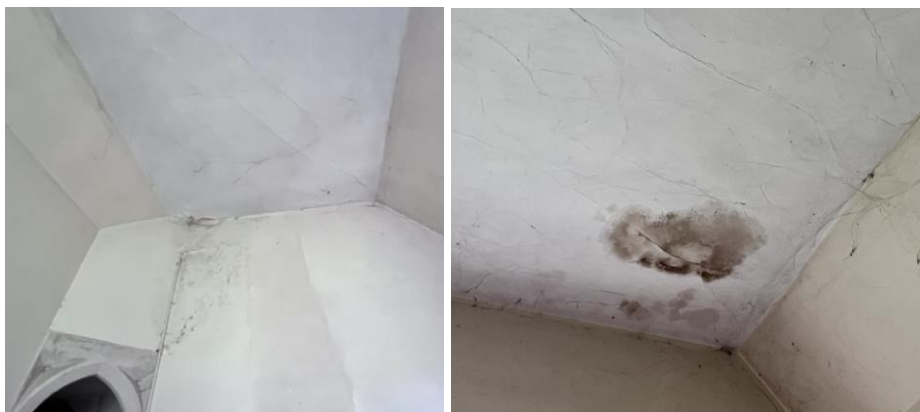
- 7.8.2\* There is some low-level peeling and hollow plaster on the east wall, and areas of plaster damage on the west wall at both high and low level. The walls may need some plaster repairs at some point, using lime plaster.
- 7.8.3\* There is a water stain on the ceiling in the south east corner that may be a result of condensation. There is also quite a bit of cracking in the ceiling plaster (figure 36). The ceiling may need renewing at some point.

Figure 36 – Vestry – ceiling may need renewing.

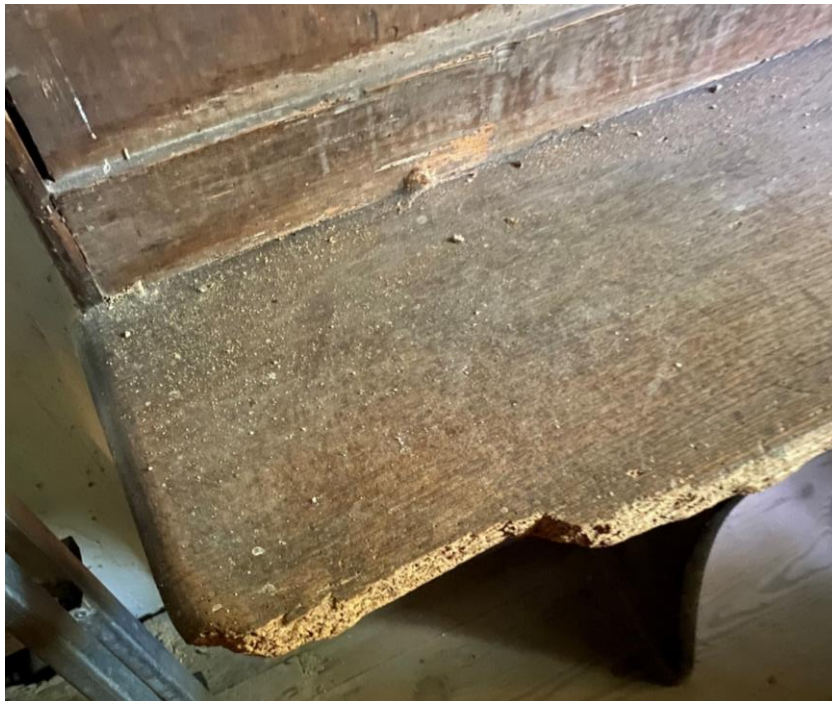
7.10.1\* The nave and south aisle pews appear to be in good condition. There is a pew at the back, on the north side of the organ gallery, that has had a corner eaten away by beetle attack and should be treated (figure 37).

Figure 37 – Organ gallery – treat pew for beetle attack.

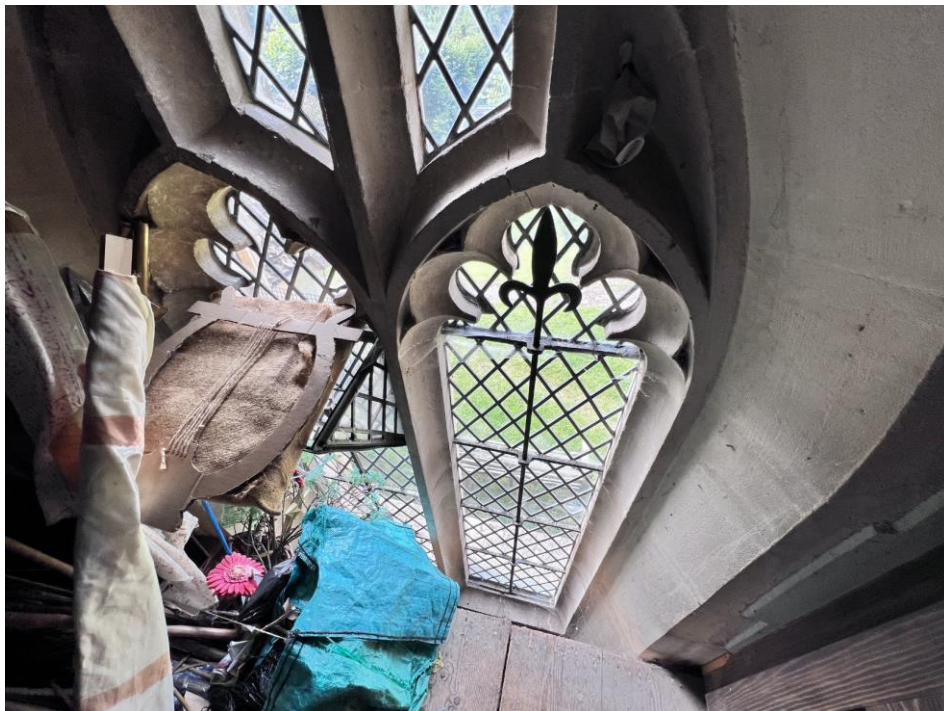
- 8.3.1 The north wall of the nave has four windows of stained and painted glass, that all appear to be in good general condition. The east end has an apex window that also appears to be good with no work required.
- 8.3.2\* The organ gallery windows generally appear to be in good condition. The north side has stained glass in good overall condition, though there were a few cobwebs that could do with clearing. The south, clear diamond glazed, window is in good condition but has stuff piled up against it (figure 38). Ideally, any stored items should be kept clear of the window to prevent accidental damage to the glazing.

Figure 38 – Organ gallery, south window – keep clear.

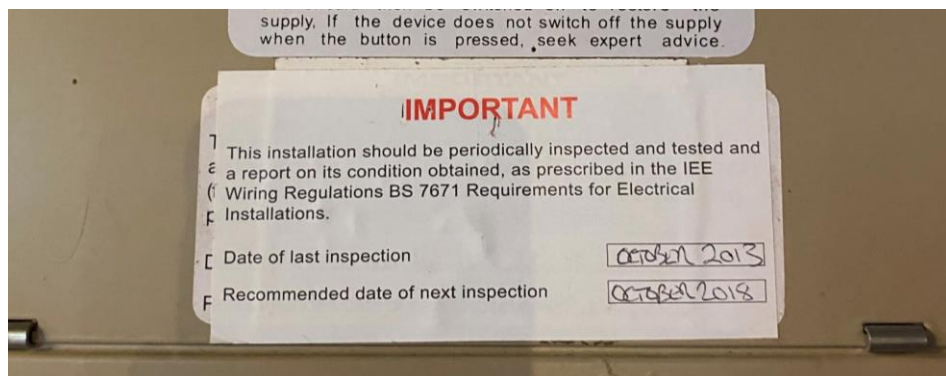
10.2.1\* The electrics should be tested every five years. The consumer box, at the back of south aisle records the last inspection as October 2013, next due October 2018 (figure 39). The date of the last inspection should be checked and booked in if needed.

Figure 39 – Electrical testing – check and book if needed.
