## Church of St Mary, Chilton Foliat

### Quinquennial Inspection

**August 2023**

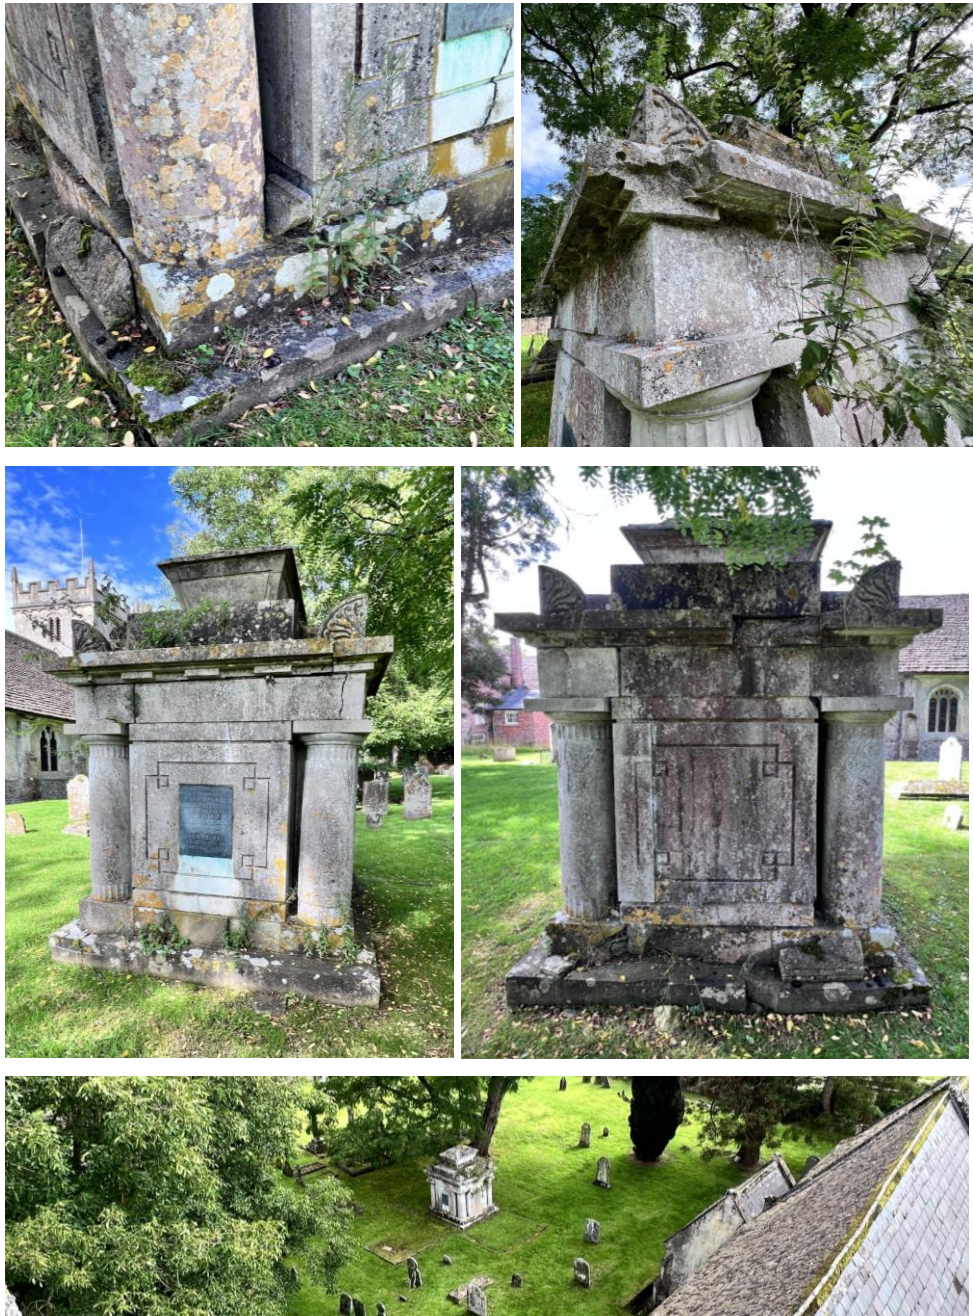
cleaning system if required. More urgently, there is quite a bit of plant growth that needs carefully clearing before it causes further damage to the stonework. **1**

Figure 40 – Pearse mausoleum – remove plant growth, repair stonework.

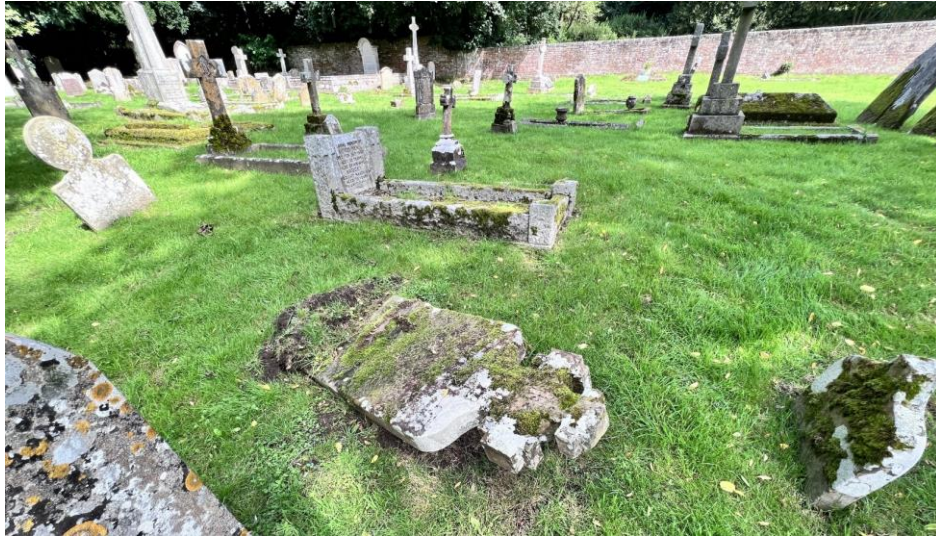
11.2.2\* There are a number of headstones and memorials with a build-up of moss and ivy, particularly on the north side of the churchyard, and south west of the tower (figure 41). Moss should be periodically removed to prevent stone damage caused by water retention. Ivy also needs to be removed from stonework and systematically dealt with in order to prevent uncontrollable spread.

Figure 41 – Churchyard – remove moss and ivy from headstones and memorials.

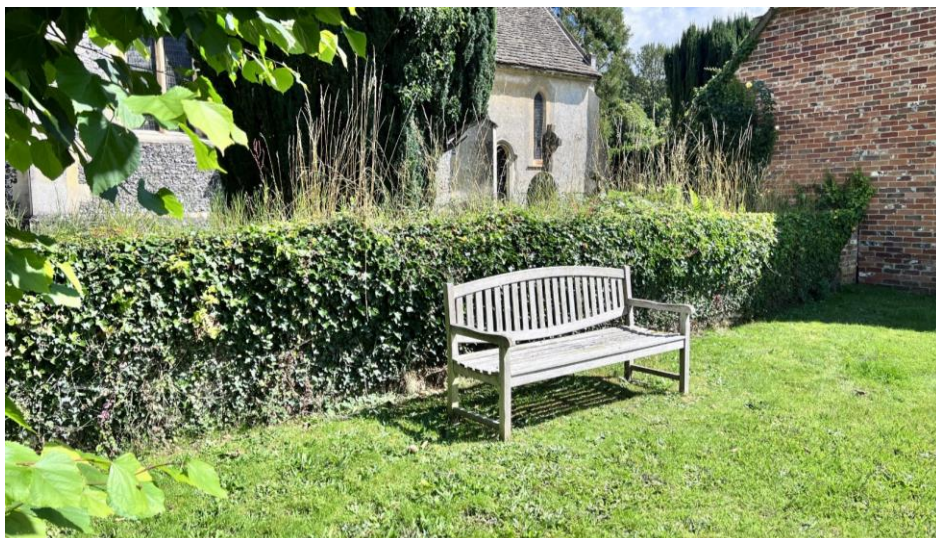
Figure 42 – Churchyard – clear ivy.

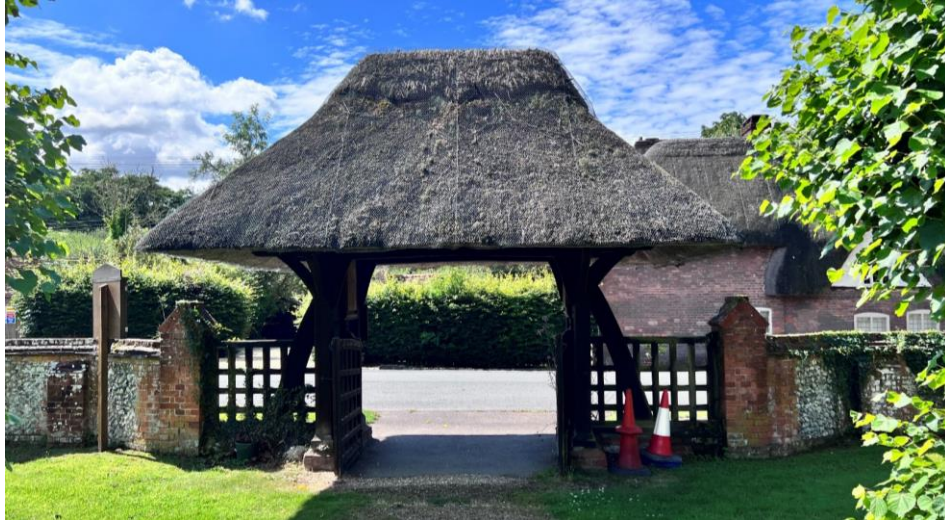
Figure 43 – Lychgate – repair/replace rotten timbers, remove ivy, renew thatch.

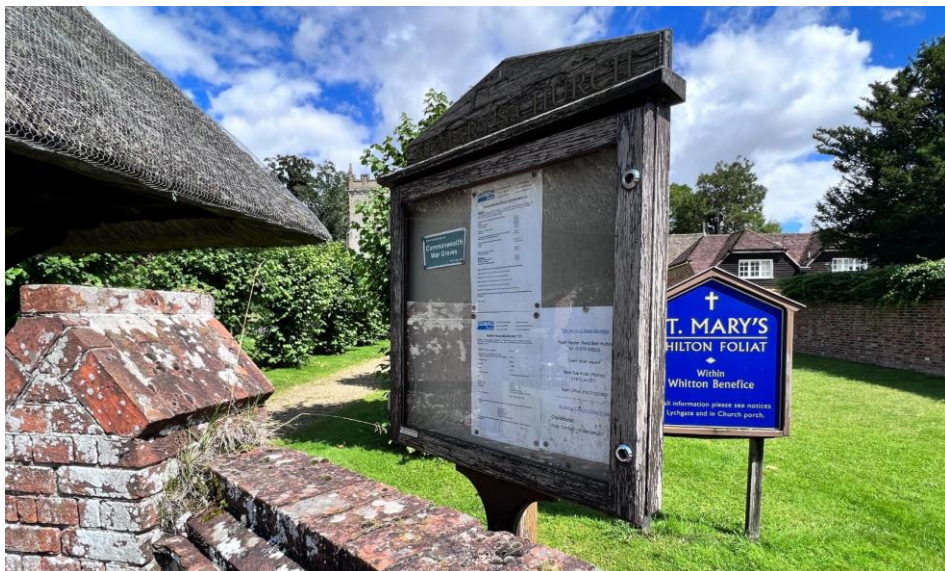
11.3.3\* The noticeboard by the boundary wall is looking a little tired and could do with some refurbishment (figure 44).

Figure 44 – Churchyard noticeboard – refurbish.
