## Church of St Mary, Chilton Foliat

### Quinquennial Inspection

**August 2023**

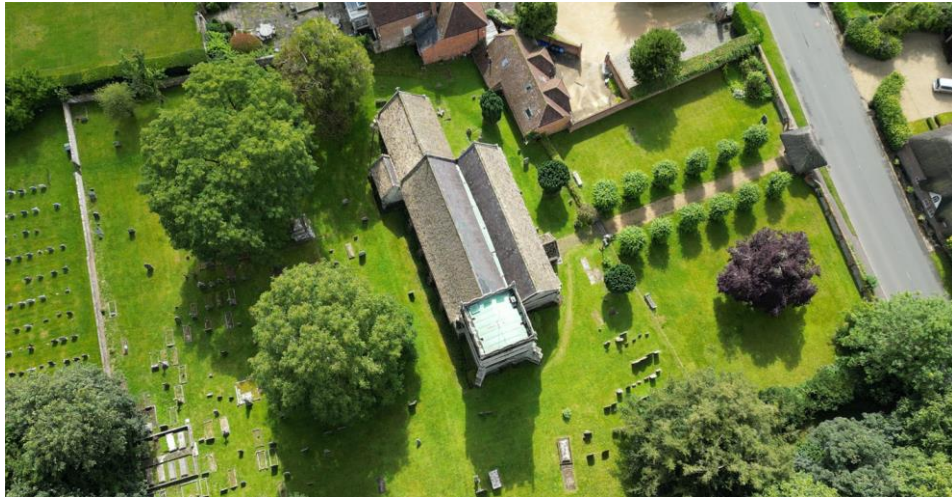
The roofs were viewed from the ground, the tower and by drone (figure 1). The chancel, porch, and the outer faces of the nave, south aisle and vestry roofs are covered with stone slates. The inner faces of the nave, south aisle and vestry are slate, and the tower roof is copper. They are generally in good overall condition, though the tower roof requires some work.

Figure 1 – Roofs from the air using a drone.

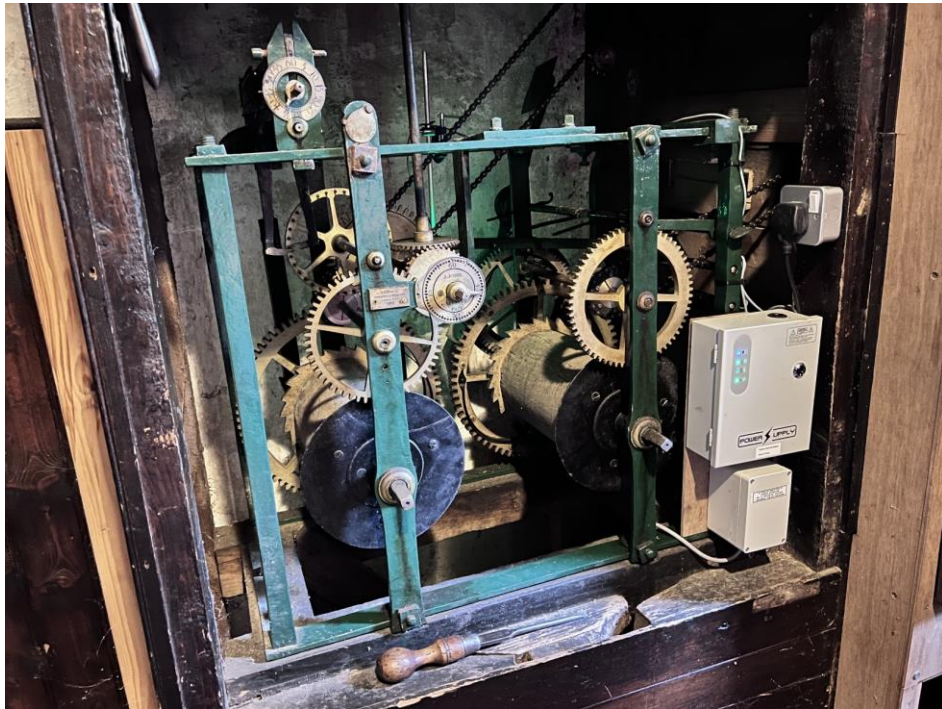
- 7.3.2 The bell ringing chamber houses the clock movement, which strikes every half hour (figure 27). The movement has been sensitively automated so that it is very accurate. It is in good well maintained working order.

Figure 27 – Bell ringing chamber – clock mechanism.

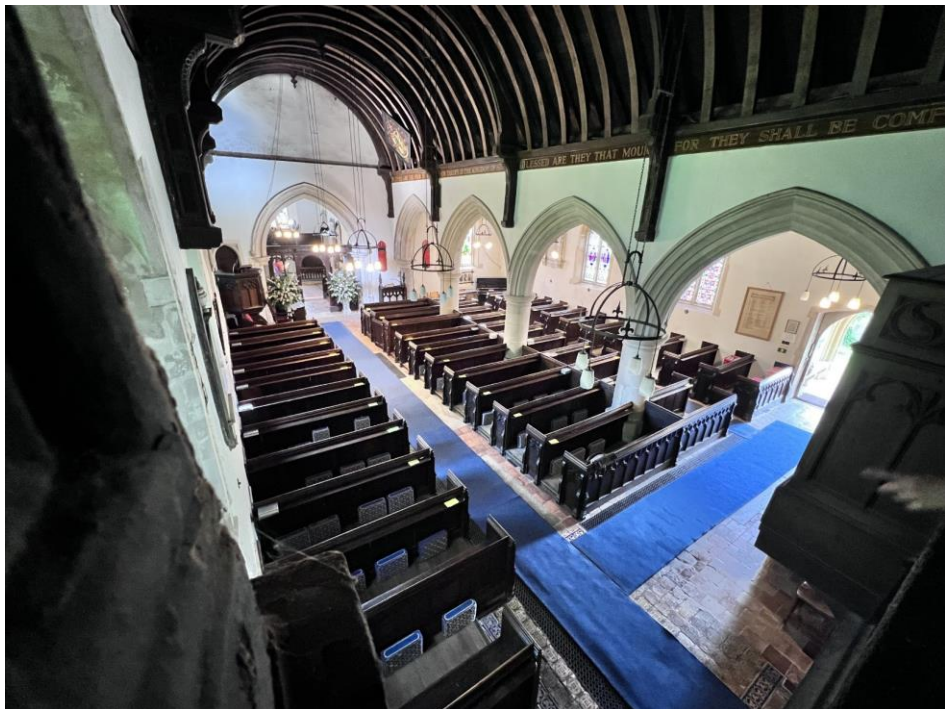
- 7.5.1 The nave is generally in good decorative order (figure 29). The metal floor grills are a bit loose in places but do not appear to be causing any issues.

Figure 29 – Nave – good overall condition.

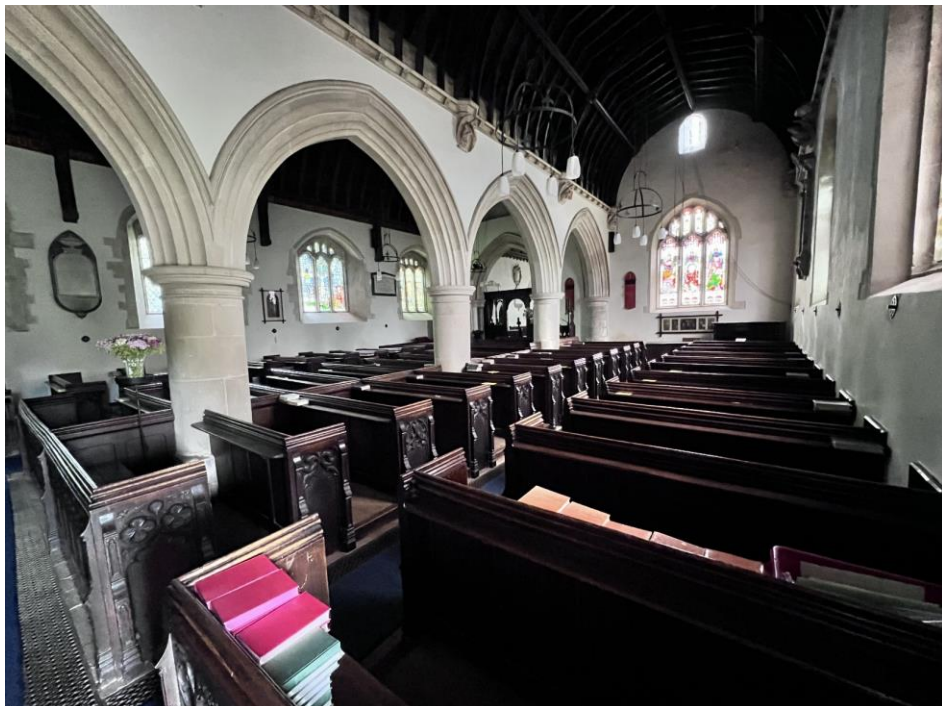
The south aisle is generally in good decorative order with no obvious issues observed (figure 32). The internal roof structure appears sound, though there is some historic staining, and the pew platforms feel solid.

Figure 32 – South aisle – good overall condition.

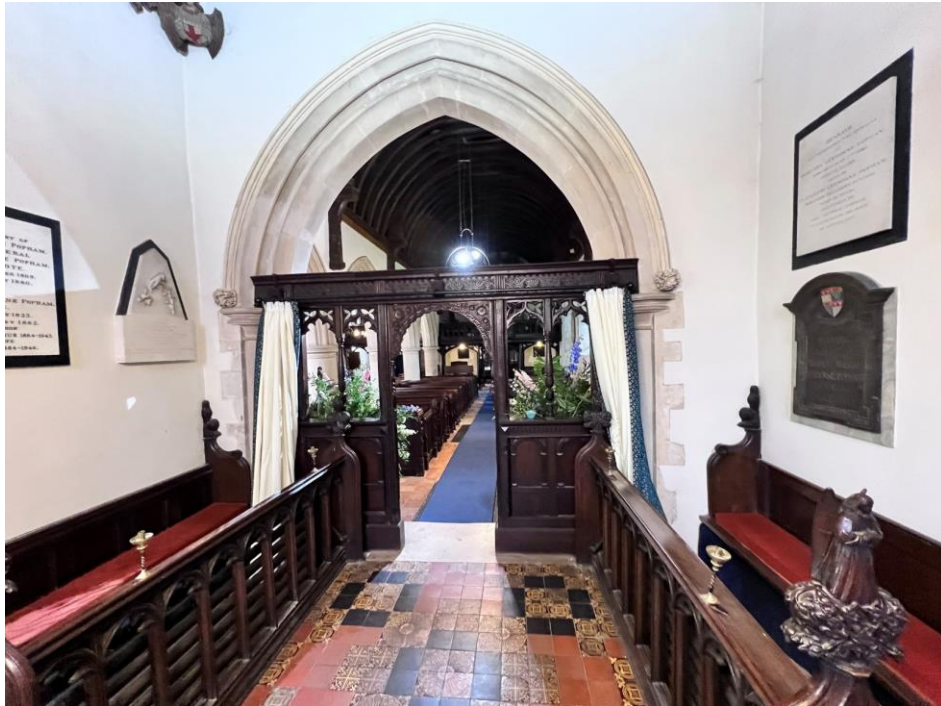
- 7.7.1\* The chancel is generally in good decorative order (figure 33). The tiled floor is solid and painted ceiling in good condition. There are a few cobwebs that could do with clearing.

Figure 33 – Chancel – good overall condition.
